# PolyArmor® 80-775

## CASE STUDY #2

**PROJECT:** Brine Storage Tank Lining

**SYSTEM:** POLYARMOR® 80-775

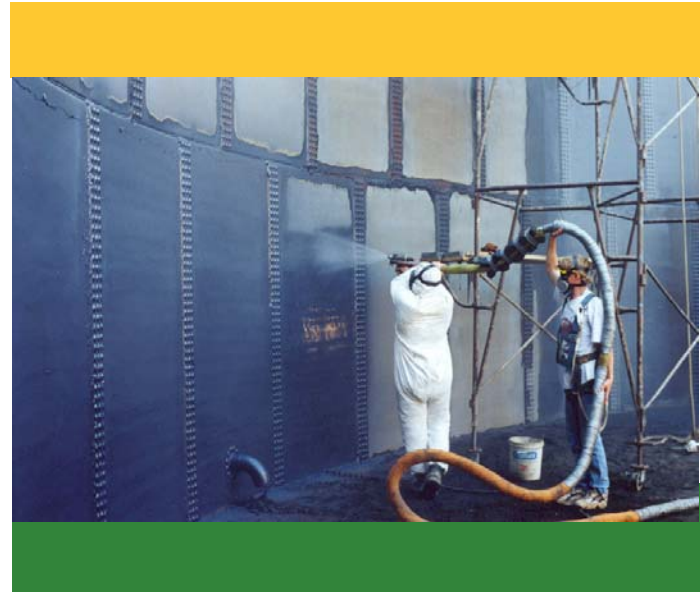
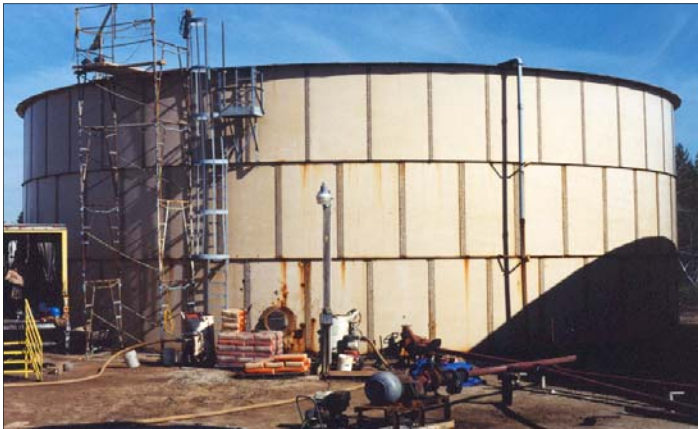
This million gallon brine storage tank had previously been lined with polyurethane. It had failed badly. The polyurethane remains were removed by sand blasting. The steel surface was blasted to a SSPC SP-10 near white metal finish.

The steel surface was badly contaminated with dissolved chlorides as might be expected. The dissolved salts were removed to a level of 20 ug / cm<sup>2</sup> with a proprietary cleaning chemical and process. The steel was coated with .080 inch thick POLYARMOR® 80-775 prior to blush set in on the steel surface.
