PolyArmor® Warrior™ 240

CASE STUDY 1: Warrior™

PROJECT: NISSAN Motor Manufacturing Corp, Canton, MS

AREA: Concrete Wastewater Tank / Pump Room, approx 7,000

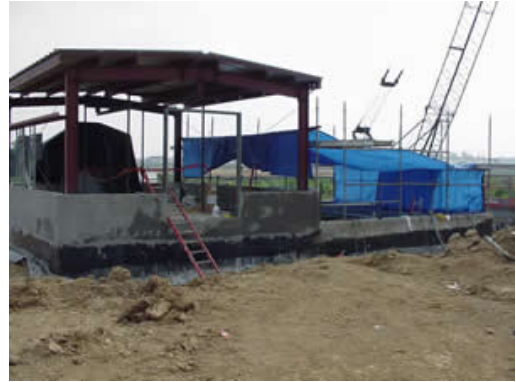
DISCUSSION: NISSAN is building a new assembly plant in Canton, MS. Part of the plant required their own waste water treating facility. In order to protect the concrete CIP pits and pump room floor from this highly corrosive environment, WARRIOR™ 240 polyurea system was chosen over a conventional polyurea spray elastomer system. The prepared concrete surface was to first receive 8 to 10 mils of the ProntoPrime (2-part urethane) priming system followed by 80 mils of the WARRIOR™ 240 polyurea system.

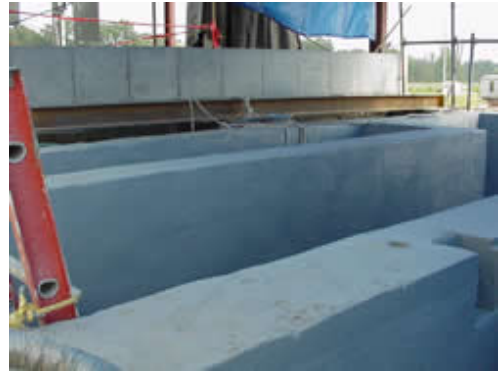
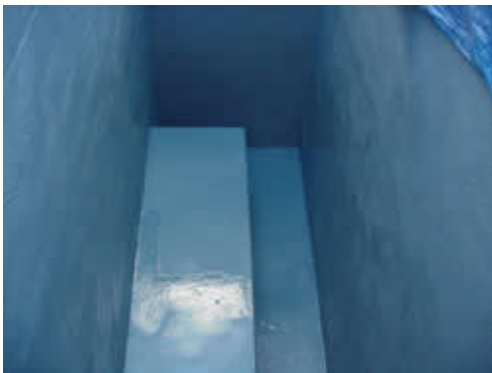
The specification called for abrasive blasting of the Cast-In-Place concrete structure followed by a re-surfacer to fill opened bugholes. Unfortunately, a re-surfacing material had not been applied and the WARRIOR™ 240 system had to be installed at a much higher film thickness over the ProntoPrime priming system in order to complete filling of the minor bugholes. The narrow size of the 40 foot deep processing pits also presented a challenge for spray application. Scissor lifts were inserted into the larger of the pits while a Spider Lift was used for access in the smaller pits.

The WARRIOR™ 240 system was applied at an average film thickness of 100 to 120 mils. Within the same day of applying the WARRIOR 240 system, several large mechanical pieces of equipment were installed in the pits. This caused some damage to the applied coating, which was then easily treated and repaired using the WARRIOR 240™ spray system. The application was completed in a timely manner and will give excellent service and corrosion protection for the concrete. The pump room floor was installed with a stipple / non-slip texture.
