CASE STUDY #1

METAL ROOF RESTORATION

PROJECT: Restore Badly Leaking Corrugated Metal Roof

OWNER: Pepsi Cola Co., Grand Rapids, Michigan

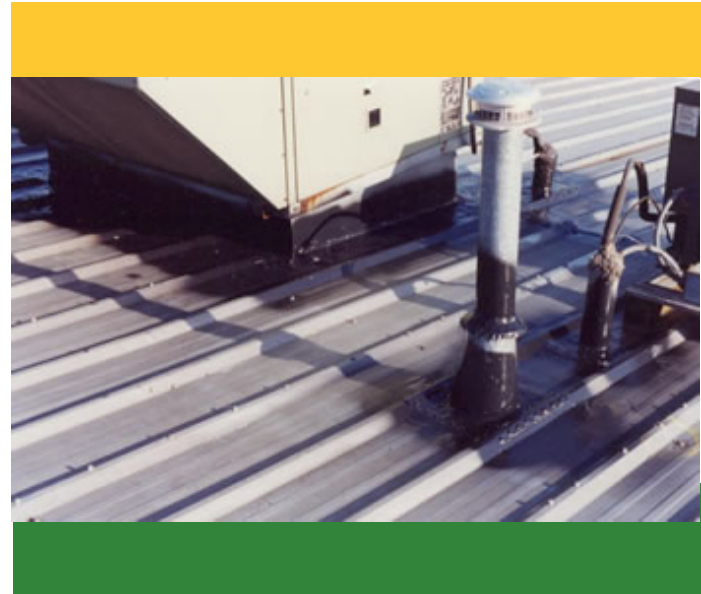
DISCUSSION: This corrugated metal style roof was over ten years old at the time of restoration by ReNew. There were over sixty-five separate leaks by count prior to re-sealing. When done, there was one very small drip that was easily repaired. Over two million sq. ft. of metal roof has been restored by NuSystems/ReNew since 1992 using POLYARMOR® coatings exclusively. (covered by U. S. Patent 5,392,583)

- ◆ Power washed - 3000 psi.
- ◆ Wirewheel brushed all areas to be coated - removed all loose rust.
- ◆ Tightened all loose screws.
- ◆ Acid etched all areas to be coated.
- ◆ Applied proprietary galv. primer.
- ◆ Sealed all horizontal and vertical lap joints, all screw heads and all protrusions with POLYARMOR® 490-572 plural under private brand.
- ◆ Overcoated all areas with aluminized asphaltic paint
